PT  
TECHNICAL REPORT M-170

Characterization of Fracture of Engineering Materials

FRACTURE CHARACTERISTICS OF STRUCTURAL  
STEELS AND WELDMENTS

by  
J. Aleszka  
Y. G. Kim

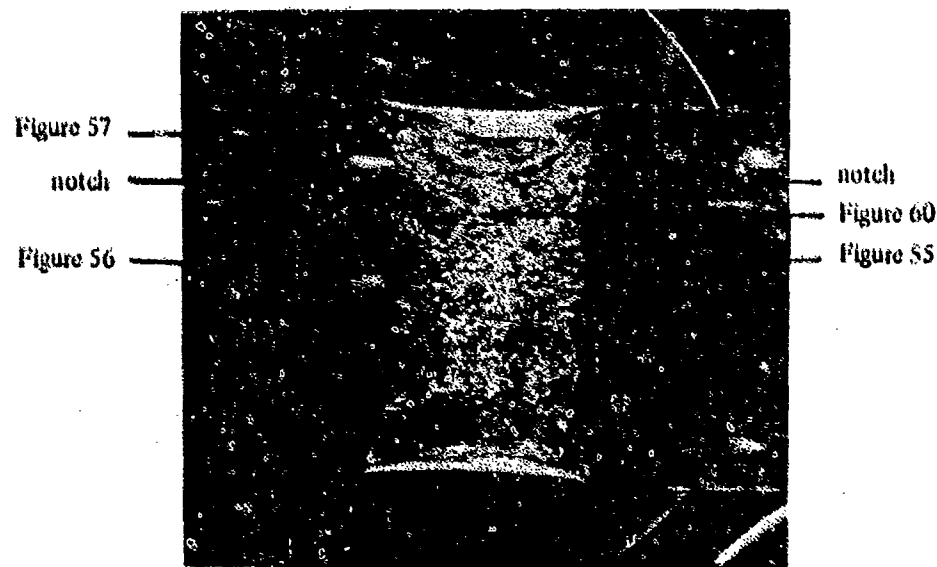
Figure S4. Fracture surface of hydrogen-embrittled T-1 plate fatigue specimen, 8x.

fatigue (Figure 54) was also composed of fatigue regions near the notches and a tensile overload region. The fatigue region, however, was not flat, but consisted of parabolic contours (Figure 55). Photographing these contours at different tilt angles revealed that the parabolic contours were actually craters in the fracture surface (Figures 56 and 57). The shape of the craters can be seen in the optical micrograph (Figure 58) taken from a section in the fatigue zone perpendicular to the machined notch. Many of these craters contained cracks in the bottom perpendicular to the machined notch. Failure occurred by quasi-cleavage inside the craters, while considerable secondary cracking outside resulted in multi-directional fatigue striations. There were no fatigue striations evident near the notch.

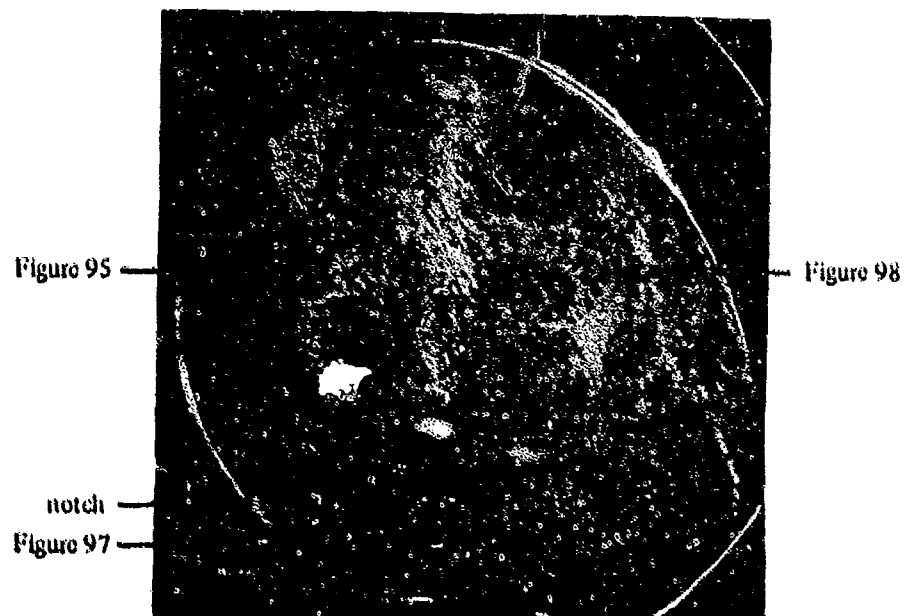
Figure 94. Fracture surface of hydrogen-embrittled HY-130 fatigue specimen, 10x.

The hydrogen-embrittled HY-130 fatigue sample is shown in Figure 94. The fatigue region (Figure 95) differs considerably from the unembrittled fatigue region (Figure 90). The parabolic contour lines on the fracture surface are similar to those on the hydrogen-embrittled T-1 fatigue sample (Figure 55). A stereo photograph of one of these contours (Figure 96) shows that like those on the hydrogen-embrittled T-1 sample (Figure 57), they are deep craters on the fracture surface. The mechanism of formation of these craters in the hydrogen-embrittled HY-130 is postulated to be the same as in the embrittled T-1 steel.

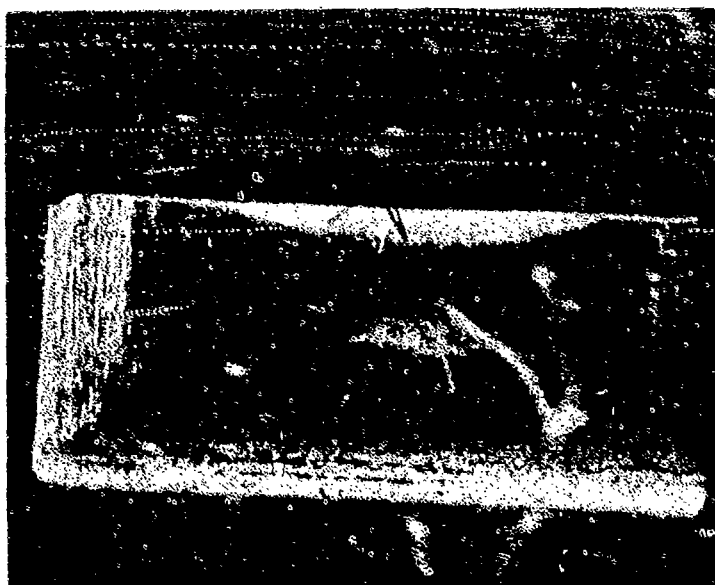
Figure 116. Tensile fracture surface of an AX-110 weld specimen, 25x.

Figure 116 shows the fracture surface of a solid AX-110 weld deposit tested in tension. Failure occurred by microvoid coalescence and dimple rupture (Figure 117). Exposure of an AX-110 weld tensile sample to hydrogen-charging prior to testing produced the fracture surface shown in Figure 118. In one area of the surface small fisheyes were present (Figure 119). The fisheye region (Figure 120) consisted of very small cleavage facets (Figure 121). This failure mode resulted from pockets of entrapped hydrogen gas. The rest of the specimen failed by microvoid coalescence (Figure 122). When the tensile specimens were temper-embrittled prior to testing, the fracture surface (Figure 123) consisted of dimple rupture and microvoid coalescence (Figure 124).

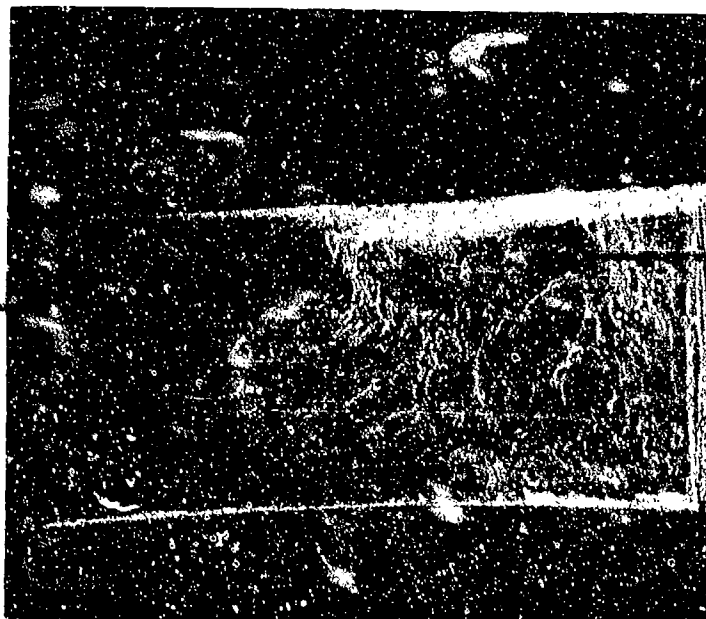
Figure 118. Tensile fracture surface of hydrogen-embrittled AX-110 weld specimen, 25x.

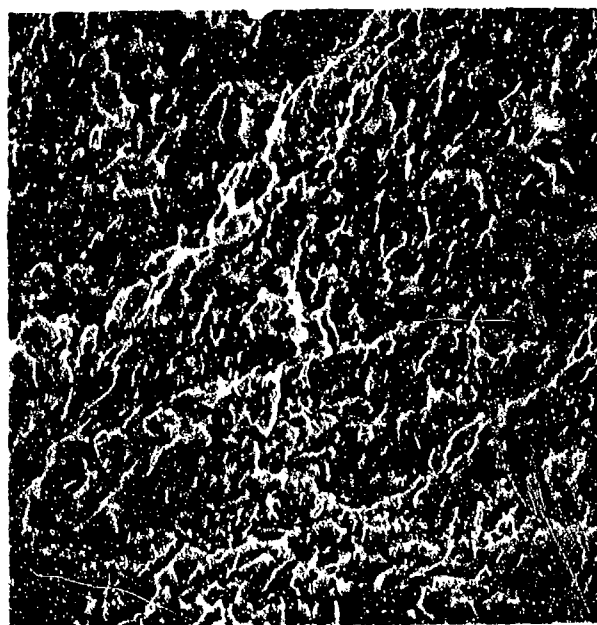
**Figure 120.** Fracture surface of region in fisheye, 1600x.

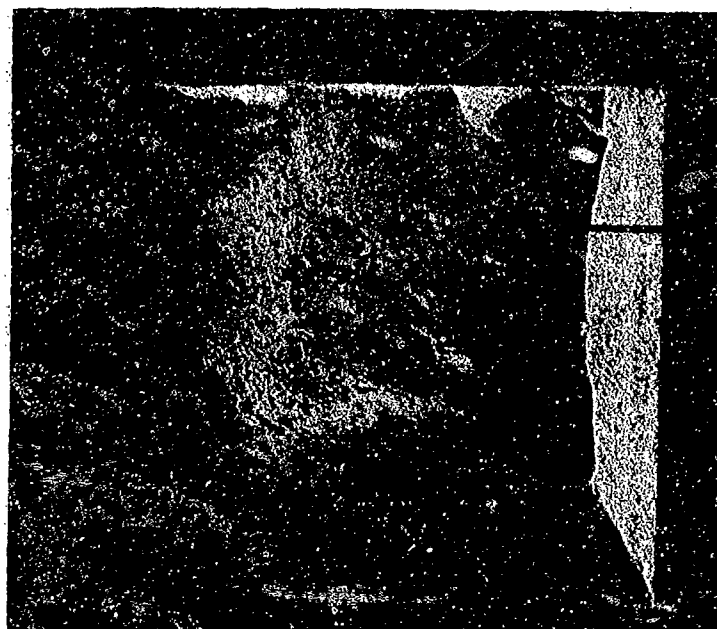
Figure 123. Tensile fracture surface of temper-embrittled AX-110 weld specimen, 15x.

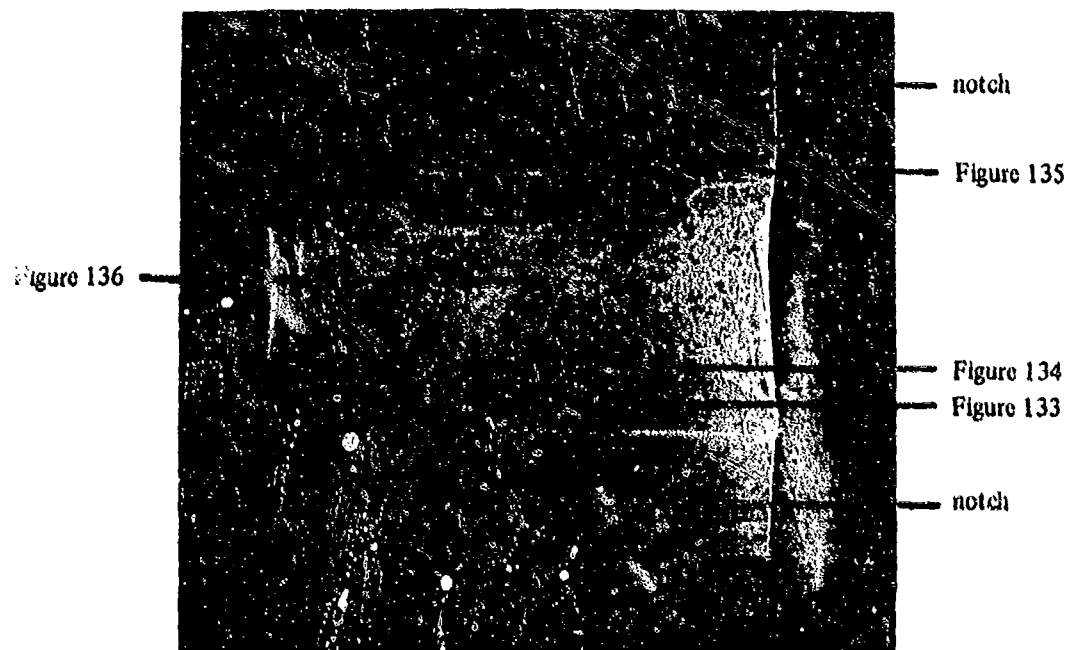
Figure 132. Fatigue fracture surface of temper-embrittled AX-110 weld specimen, 11x.

shown in Figure 132. The fatigue region (Figure 133) contained relatively few distinct fatigue patterns (Figure 134). There was evidence of lamellar tearing near the transition region from the fatigue to tensile overload failure mode (Figure 135). Failure in the overload region occurred by dimple rupture and microvoid coalescence (Figure 136).

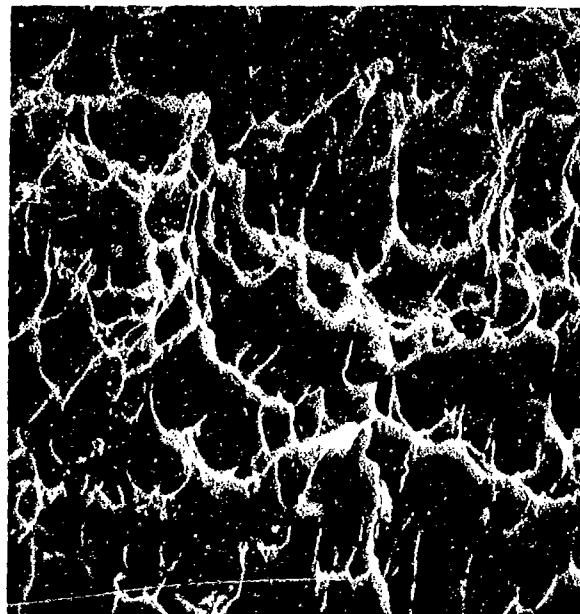
Figure 158. Fatigue region of fracture surface of AX-110 weldment containing LOP, 1700x.

center of the specimen. Fatigue striations originating from the defect were fairly well developed and easily recognizable (Figure 158). Rapid fracture in the outer portion of the specimen was by dimple rupture (Figure 159).
